**MARYLAND HISTORICAL TRUST
DETERMINATION OF ELIGIBILITY FORM**

Property Name: "Farmlands" (Tenant/Gardner's Cottage) Inventory Number: BA-2427
Address: 614 Hilltop Road on the grounds of Catonsville High School Historic district: yes ☒ no
City: Catonsville Zip Code: 21228 County: Baltimore County
USGS Quadrangle(s): Baltimore West
Property Owner: Board of Education of Baltimore County Tax Account ID Number:
Tax Map Parcel Number(s): 515 Tax Map Number: 101
Project: Disposition of the Farmlands Tenant/Gardner's Cottage Agency: Board of Education of Baltimore County
Agency Prepared By: MHT
Preparer's Name: C. Andrew Lewis Date Prepared: 9/9/2003
Documentation is presented in: MHT Library (MIHP Form BA-2427)
Preparer's Eligibility Recommendation: ☒ Eligibility recommended Eligibility not recommended
Criteria: ☒ A ☐ B ☒ C ☐ D Considerations: ☐ A ☐ B ☐ C ☐ D ☐ E ☐ F ☐ G
Complete if the property is a contributing or non-contributing resource to a NR district/property:

"Farmlands" (Tenant/Gardner's Cottage)

Maryland Inventory of Historic Properties Form

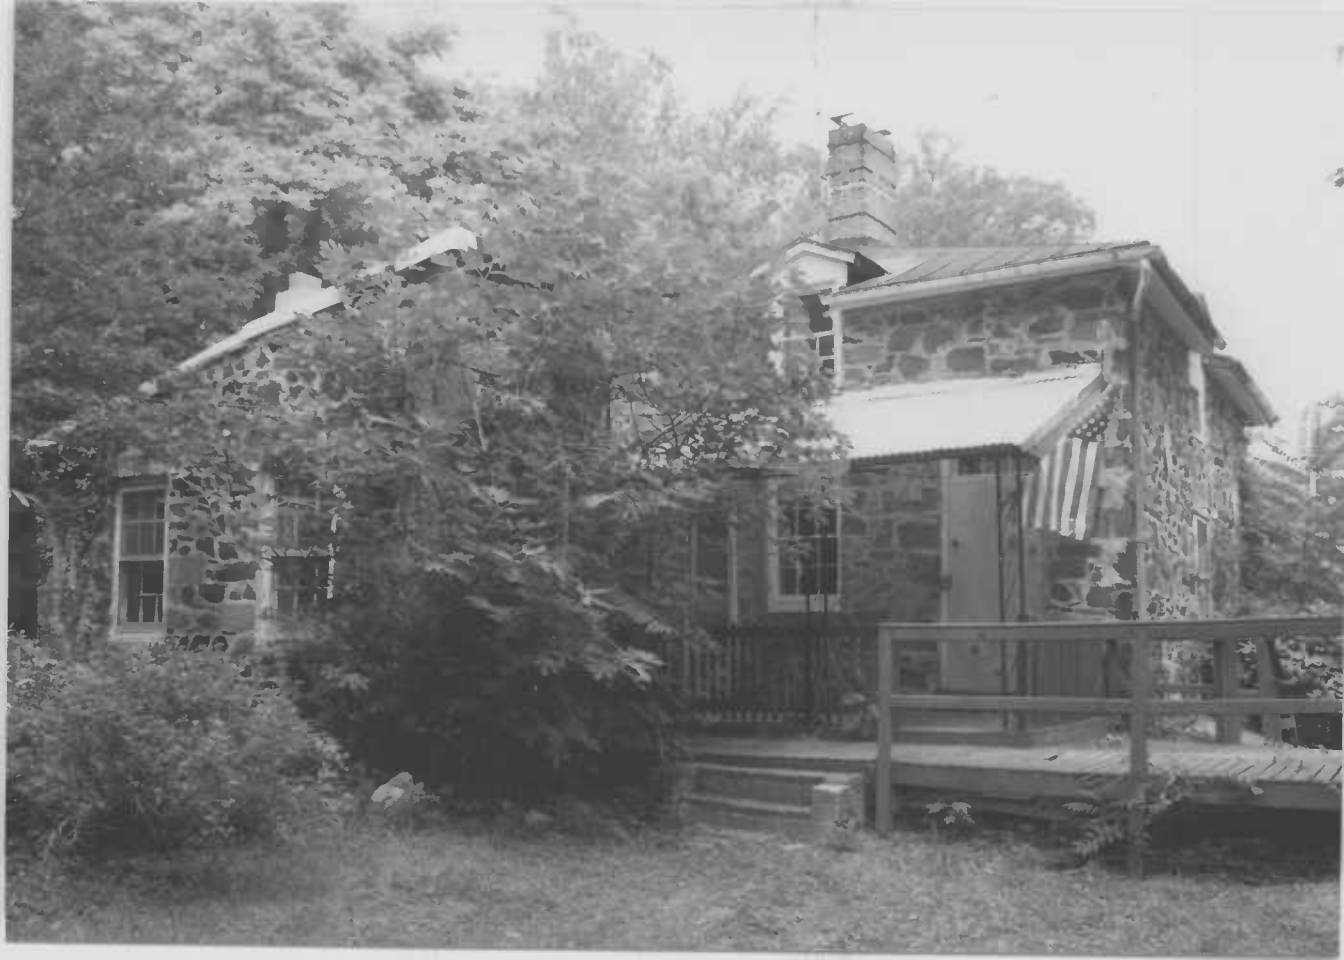
1/7

Gardener's Cottage,

South & East elevs

The south elevation of the main block on the first story has six-over-six sash with a wood lintel below a splayed brick jack arch in the east-center bay. This window has a wood sill, a beaded-interior-edge frame that is mitered at the corners, and shutter hinges. The east bay has a boarded-up door with a wood sill, a splayed brick jack arch, a beaded interior edge, and a three-light transom. There is a diamond-plate tie rod between these two bays. The stonework has a gray mortar with some traces of penciling, and one of these pencil lines passes behind the diamond-plate tie rod. The second story has a wall dormer with a one-over-six sash in the east-center bay. The top sash breaks through the eave and the dormer has a gable roof. The west jamb of the window opening has brick in the wall and there is a wood sill and plain trim. The two west bays of the main block are now covered by the addition, which will be discussed later. On the south elevation is a new wood porch with a corrugated fiberglass roof.

On the east elevation the foundation has a cellar entrance in the south bay with a new wood lintel that has two courses of brick above it. The first story has a six-over-six sash in the center that is identical to that on the south elevation. There are three diamond-plate tie rods, and the second story has a dormer like the south elevation, but with a six-over-six sash. There is a wood box cornice.

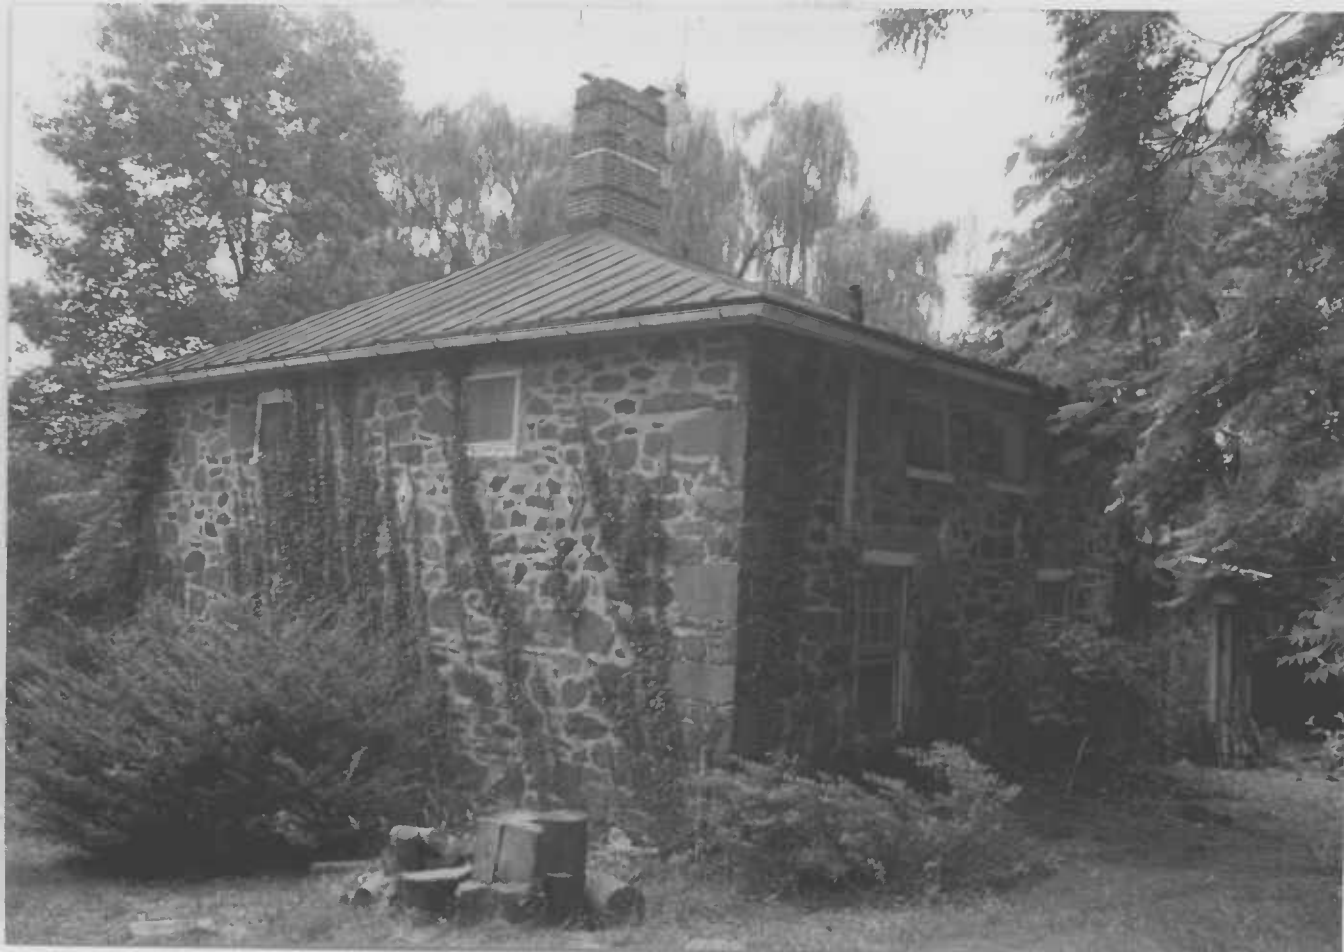
2/2

Gardner's Cottage,

north weste leus

The north elevation foundation has a narrow window opening in the east bay. The first story has no openings. The second story has two six-light frieze windows with beaded-interior-edge mitered frames and straight brick jack arches. There are two diamond-plate tie rods. The west elevation of the main block, on the first story, has a typical six-over-six sash with a granite lintel above a wood lintel on the north bay. The south bay has a typical six-over-six sash. Between the two windows are some small wood nailing blocks in a horizontal line at the level of the wood lintel and in a vertical line at the center of the elevation. There are two diamond-plate tie rods. The second story has two six-light frieze windows, the north one set slightly south of the first story north bay and the south one set close to center.

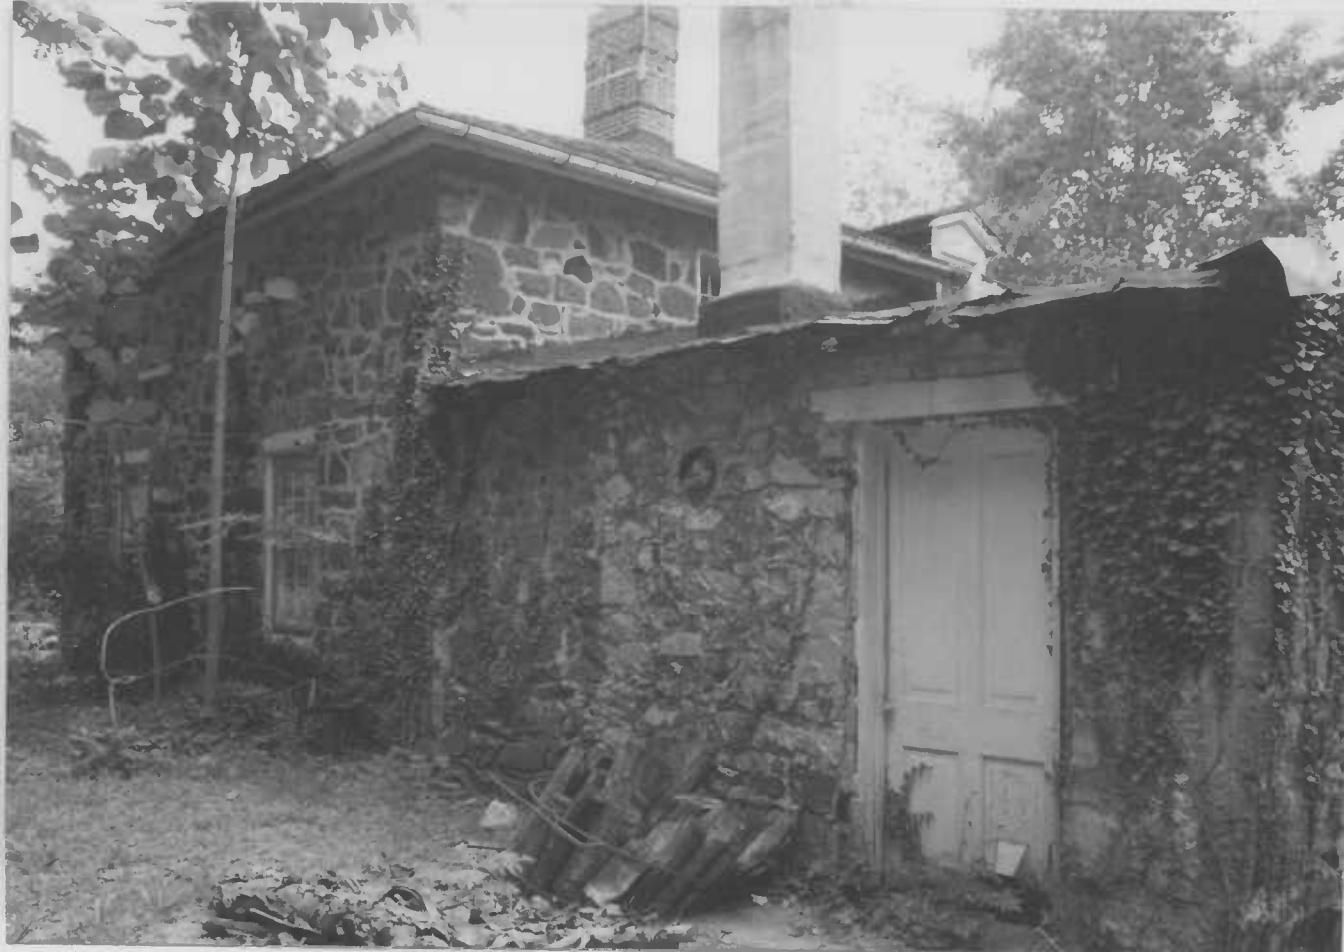
3/7

Gardener's Cottage,

West elev., fr. South

The west elevation of the wing has a stovepipe hole in the center of the wall that leads to a parged, rebuilt chimney. To the south of this interior chimney is a four-panel door with sunk double fields, ogee panel moulds, and a beaded-interior-edge frame. There is a wood lintel with brick above it. There appears to be some original pointing here. The mortar was off-white, and was then pointed with a dark gray mortar with a flat joint, and then white rectangles of penciling were painted on the mortar. There was a porch or shed on the south bay of this wing, and only the concrete pad for it still survives, but the stone wall in this location is painted silver.

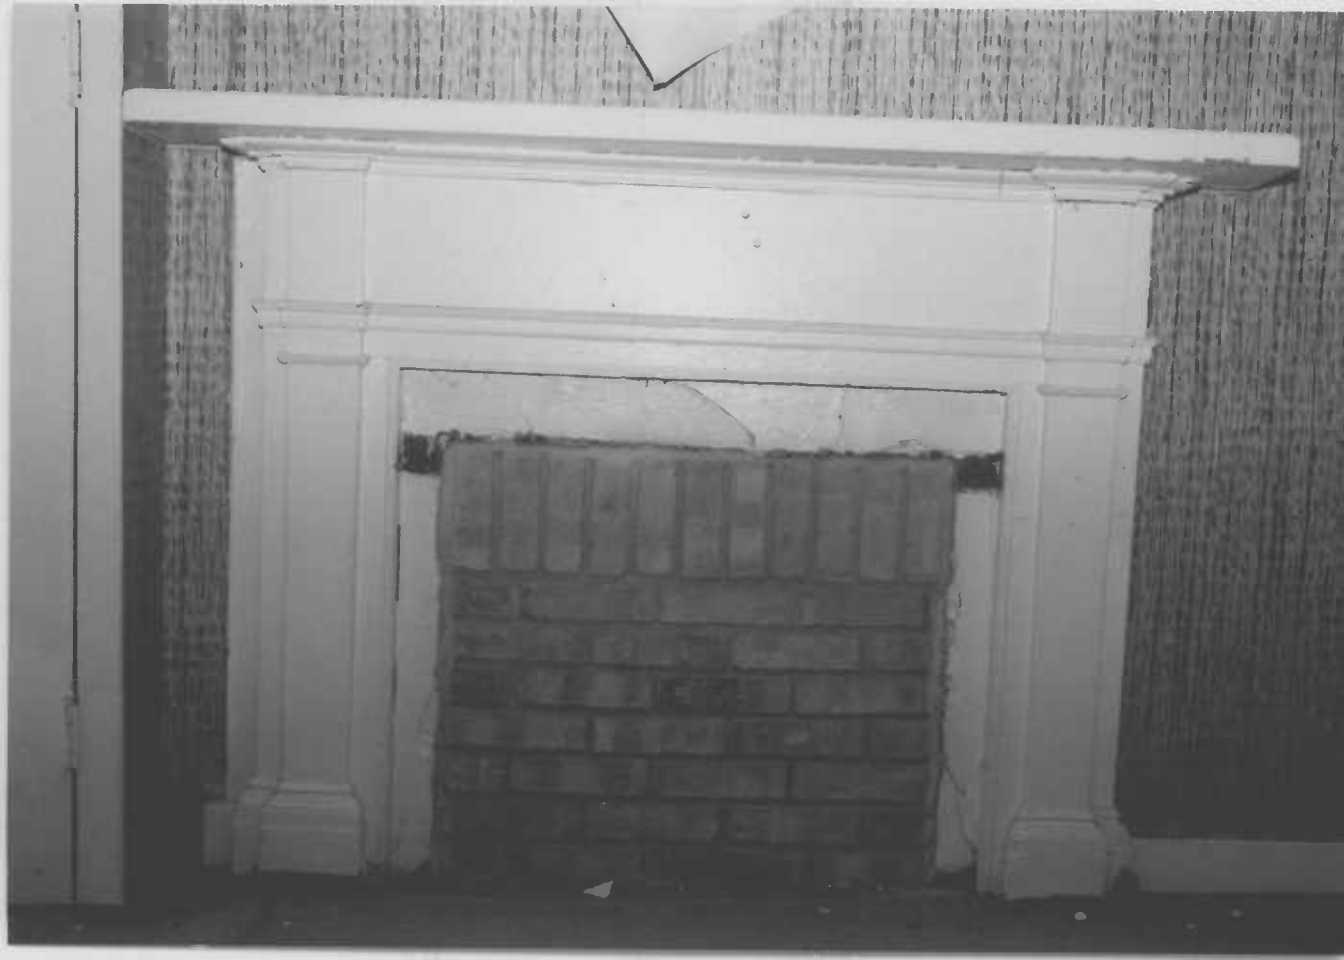
6/7

Gardner's Cottage,

East Chamber mantel

In the east chamber, the west elevation has a fireplace that is bricked-in. There is a wood mantel with plain pilasters, a plain frieze, and plain impost blocks. The bed mould has a Greek ovolo above a cavetto and bead. The mantelshelf is also plain. To the north of the fireplace is peg rail that has been wallpapered over. There is a stovepipe hole above the mantel. To the south of the mantel is a built-in closet with two four-panel doors, each door consisting of four square panels set one above the other. The bottom two panels have fields while the top two are flat and sunk. The doors are hung on three hinges each, with ball finials, and have a mortise lock with a brass knob. South of the closet is a dresser that has been walled in, and the drawers are now missing. The top sash of the south dormer window originally had six lights, but the muntins have been removed. The bottom sash has a shallow Roman ovolo profile and is probably reused from the frieze window that apparently was located here and was converted to a dormer. The east window dormer muntins have a deep Greek profile cavetto. The ceiling lath is circular-sawn and appears to be fastened with cut nails. On the north elevation, to the east, is a short door above the stairway. It is set about one foot above the floor and has two tall panels with sunken fields and no panel moulds. It is hung on cast iron butt hinges with five knuckles and fast joints and has a small cast iron cabinet rim lock.

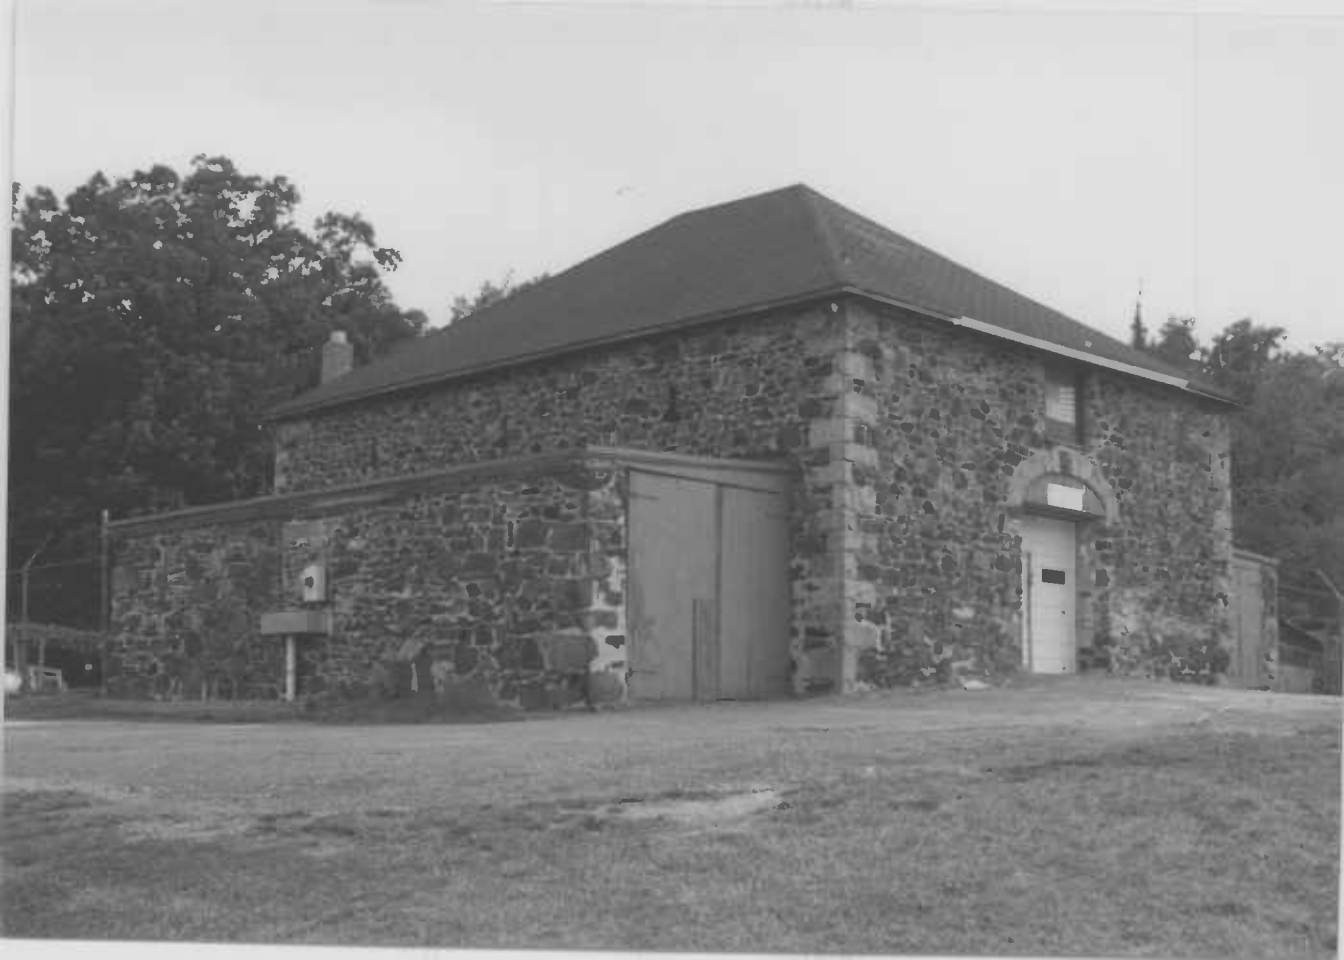
2/7

Carriage house - west & south elevs

About 125 feet north of the high school is a barn or carriage house that was also associated with the Farmlands property. It faces south toward the school and is now used as a maintenance shed. It is a two-story, three-bay by three-bay rubble stone structure of local granite with quoins. It has a hip roof with asphalt shingles. There are one-story, three-bay by one-bay wings of rubble stone with slightly sloping roofs on both the east and west elevations.

The south elevation of the center section has a modern steel roll-up door in the center of an original opening that is segmentally arched and has stone voussoirs. The arched area above the rectangular doors has infill with beaded-edge-and-center boards. Above this opening is a new small plywood door in an original opening, with a wide, plain wood frame. There are no openings in the south and east bays. The south elevation of the west wing has a pair of large vertical-board wood doors hung on machine-made strap hinges. The south elevation of the east wing is identical to this. The west elevation of the west wing has a door opening in the center that is infilled with rubble and has a splayed-brick jack arch. There is a cornice of two courses of corbelled brick. The second story of the main block on the west elevation has three narrow slit vents that are bricked in on the interior. The north elevation of the west wing is identical to the south elevation of this wing. On the north elevation of the main block, the first story has two door openings with stone voussoirs, one in each of the east and west bays. The east bay now has a one-over-one sash with rubble stone infill below it. The west bay has brick infill at the top and rubble stone infill at the bottom, and a brick exterior chimney covers the west end of this opening. The second story has a plywood door in the center that is hung on tapered strap hinges with round ends. The opening has stone voussoirs. The north elevation of the east wing is the same as the north elevation of the west wing. The east elevation of the east wing has no openings. The east elevation of the main block, on the second story, has three slit vents.
